# Town of Windsor, NC

## CPN Institute Re:NC Report Facilities Revitalization Overview

Site Visit: May 19-20, 2011  
Final Report: September 1, 2011

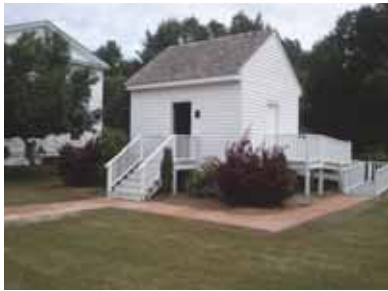
<b>Observations</b>	<p>Located within 300 yards of Cashie River, pedestrian access to river is good.          Lies several feet above Cashie River elevation.          Building has been recently flooded.          Located across from City Zoo which is a significant activity zone for community.          Chain-link fence surrounding Zoo acts as a physical and visual barrier.          Building was relocated to this site approximately 30 years ago.          This is the building's third site location.          Several rooms contain metal wall and ceiling panels.          Floor 2 has high ceilings and tall double-hung wood windows, single-glazed.          Adjacent one-room school house building.          Building 'seems out of place' for significance to community.</p>
---------------------	--

<b>Recommendations</b>	<p>Raise building if kept in current location and reinforce foundation.          Raising building will pose aesthetic and accessibility issues.          Scale of foundation may not 'feel' right for this building.          Consider: Relocating closer to main Downtown District.</p>
------------------------	--

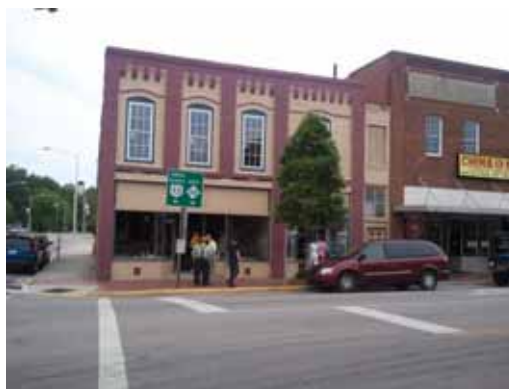
Building is located on a corner in historically significant Downtown. Corner locations provide for greater exposure and opportunities for windows. This building appears to be at the lowest elevation of the Downtown group observed and is expected to flood again during significant weather event. Building has been through two significant floods in past 11 years. Masonry bearing walls appear solid. Wood floor framing appears solid (no deflection noticed). Upper floor requires further inspection due to neglect and evidence of roof leaks. Rear wall has historical character and needs significant repairs. This building has a rear yard which is a rare opportunity in a Downtown. The yard could become a very nice amenity.

How to flood-proof main level?  
 Provide retractable awnings (2) over main storefronts.  
 Re-paint brick to enrich facades.  
 Repair rear wall and high-light its character with paint.  
 Capture rear yard as a people-oriented space...flowers/seating/grass/pavers

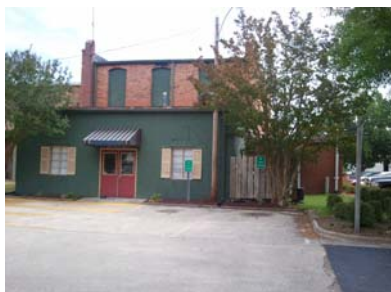
Building front facade is more contemporary than other buildings observed. The brick pattern and condition of the brick on the front appears to be constructed more recently. The storefront is aluminum framed system with no intermediate mullions and lacks historical character. This building did not receive flood damage. Upper floor requires further inspection due to neglect and evidence of roof leaks particularly at edge of roof. Rear wall has some historical character with arched upper windows. There is a 1-story 'addition' on the back composed of painted concrete block (CMU). The interior stair is wide and has the potential to 'draw' visitors inside and upstairs.

Upgrade awning over main storefront. Add character using pots with flower. Replace upper floor windows with traditional wood windows with mullion pattern. Connect upper floor windows with a single permanent awning. Replace aluminum storefront with a traditional entry using durable materials. Capture rear yard as a people-oriented space...consider converting several parking spaces to patio with landscaping.

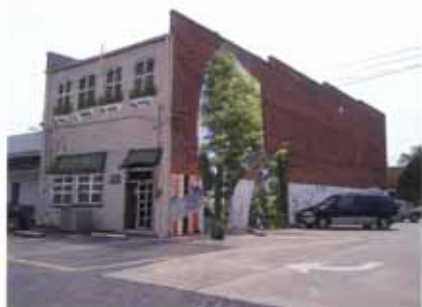
Semi- traditional storefront with simple brick detailing.  
 The brick pattern includes arched windows on second floor.  
 The storefront has a deep recess with large permanent awning. The storefront is not inviting to pedestrians and needs to be opened up. This will make it feel a part of the Downtown storefront experience.  
 Building has been through two significant floods in past 11 years, and is expected to flood during next high water event.

Permanent awning is out of scale with front façade and could be replaced with a more traditional approach using lighter, more colorful materials.  
 Add a traditional cornice across top of front façade.  
 Introduce signage.  
 Consider introducing streetscape scene along wall facing parking lot.  
 Add awning over rear entrance with patio-like seating areas. Landscape a small area in the rear.  
 Open up blocked up windows in rear wall.

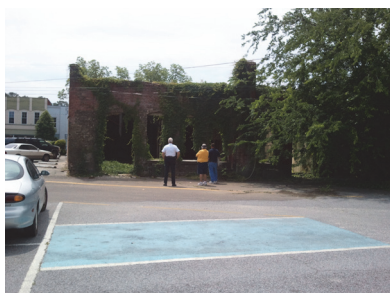
This building (of those observed) is the largest distance from the River. Traditional storefront with good brick detailing. The brick pattern includes arched windows on second floor with accents. The storefront is missing and is currently 'boarded up.' The rear half of the building has been burned away. The rear wall is 1-story in height and remains standing. The wall has 4 arched windows and an arched entry, and a chimney (flue). There is a lot of potential for this building. The large parking area around the building (combined with 122 East Granville) could become a very special area in the Downtown if a portion of the parking were devoted to people/green space.

**Front:** Replace storefront for multi-tenant entrance. Replace windows with traditional mullion pattern. Re-paint front façade to accent brick character.  
 Add a retractable awning at each storefront.  
**Rear:** Consider introducing streetscape scene along wall facing parking lot. Replace floor with concrete slab and convert to outdoor space. Integrate trellis to help define the space and use for shoring of existing walls.

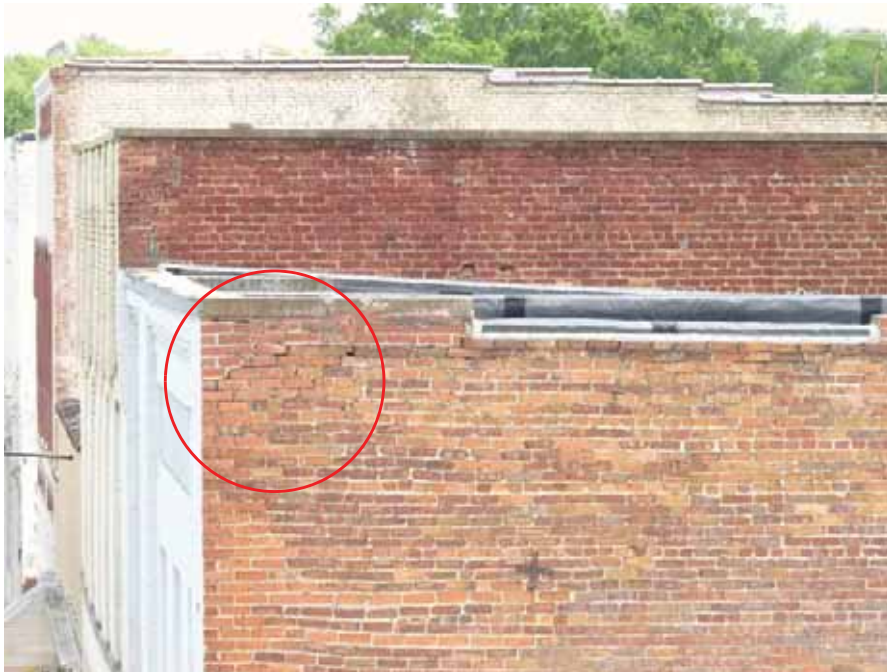
40. Building I - Parapet needs repair.I

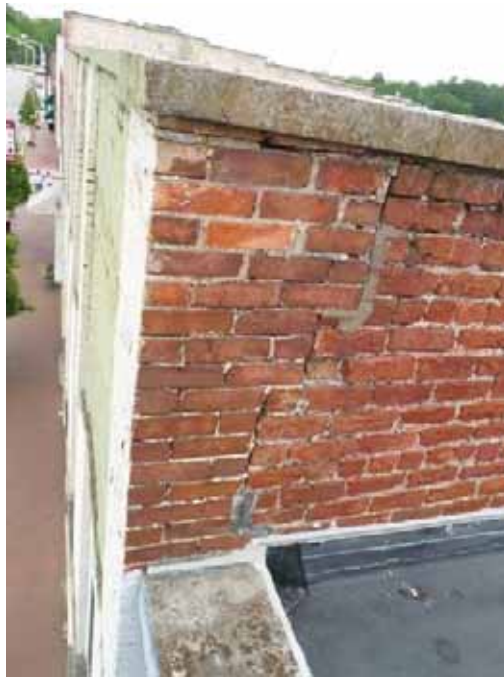
44. Building J - Parapet needs repair.

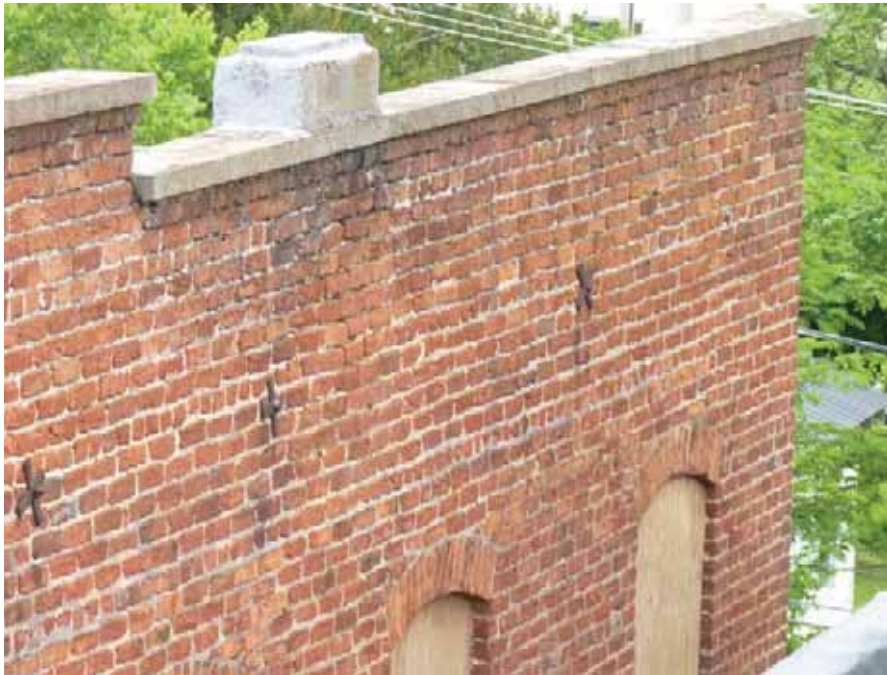
53. Building L - some repairs are needed on the west face of the west parapet.

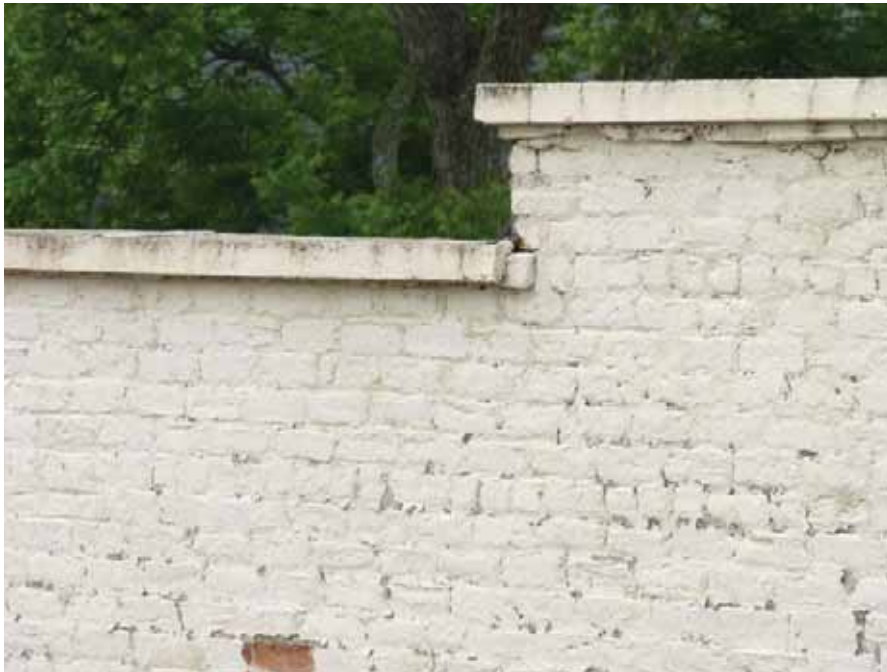
54. Building L - east face of east parapet appears to be in good condition.

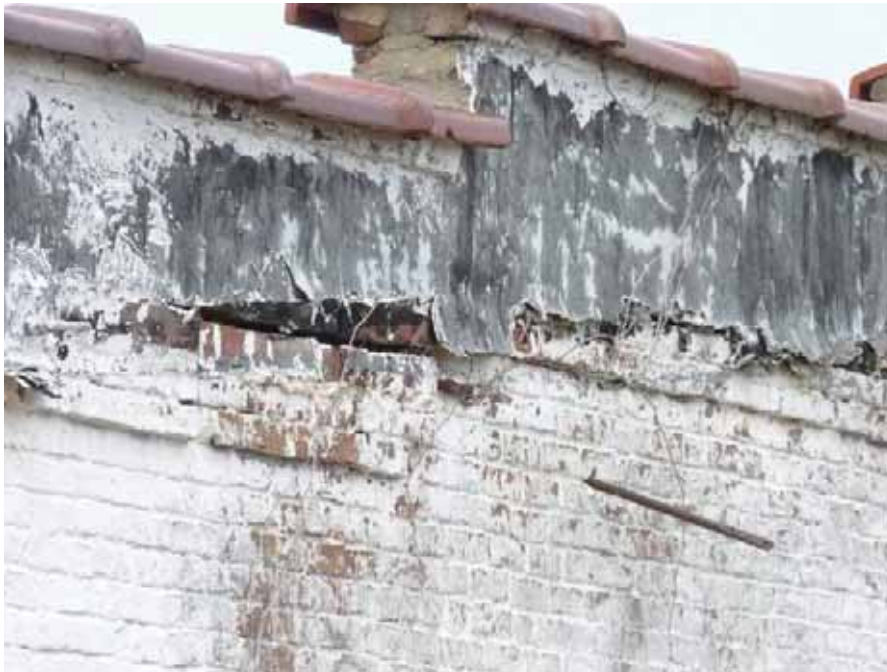
70. Building P - minor parapet repair is needed to fill the raggles where the counterflashing was removed.

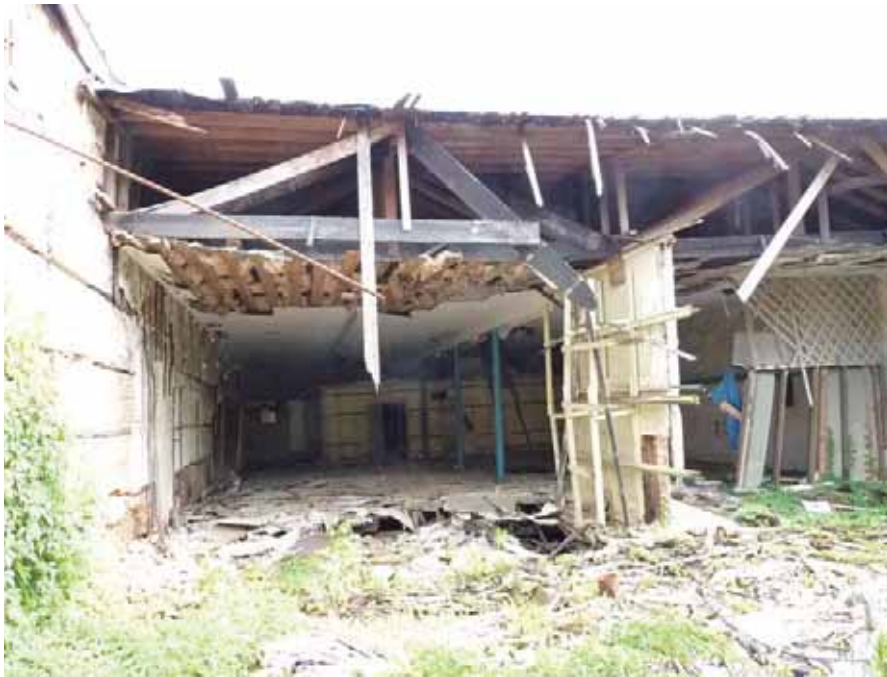
114 E. Granville Street      This roof appears to be keeping the interior of the building dry, however, the northerly 20' of the roof and roof structure has collapsed. The charred roof truss members are evidence of fire damage. The extent of the fire damage within the remaining roof structure should be determined.

78. Building Q - rear 20' of the roof structure has collapsed; note the charred roof truss members as evidence of fire damage.

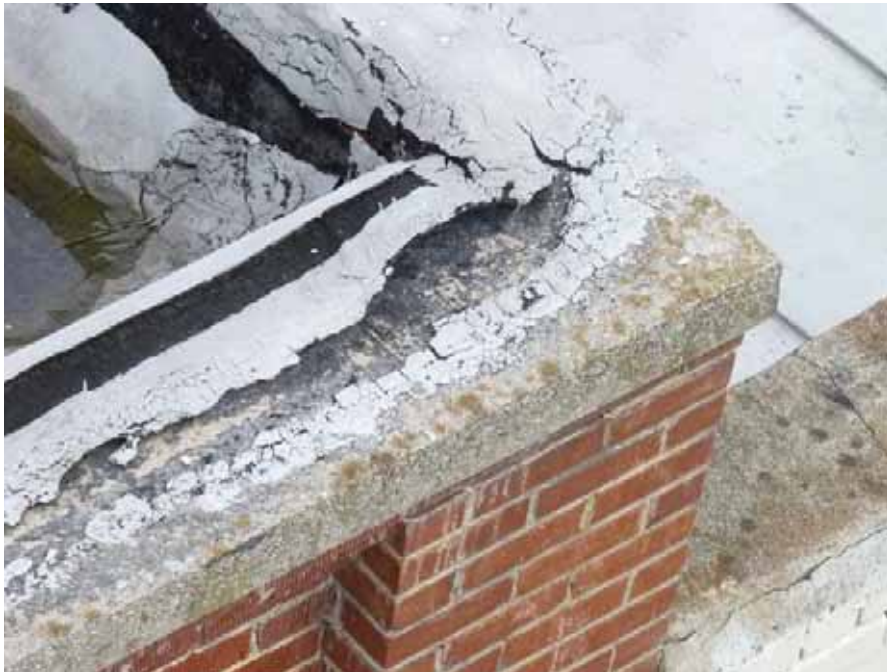
90. Building R -flashing at parapets is slipping and has pulled loose from the top of the coping.

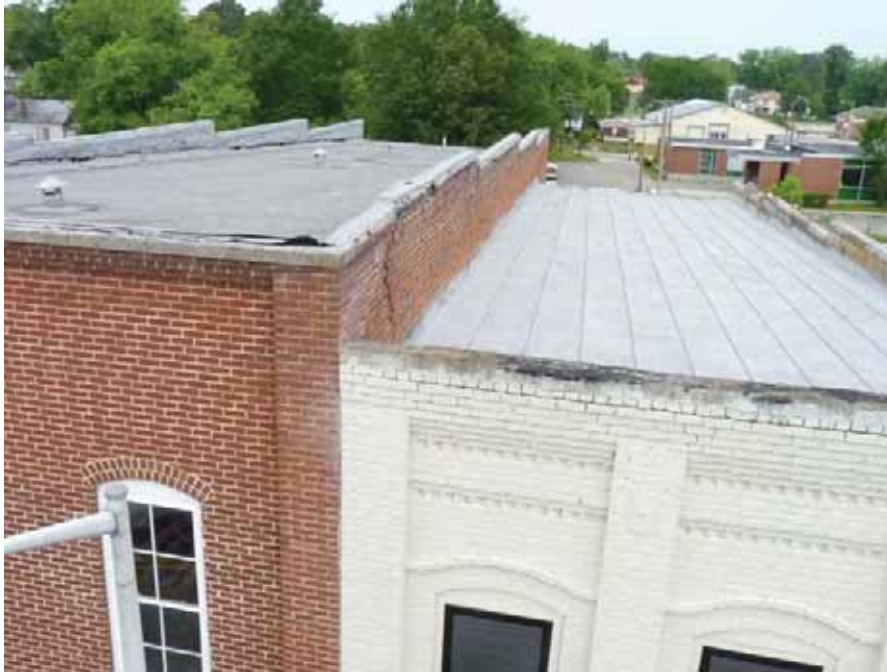
91. Building R - masonry repair is needed here. See also photograph 92.

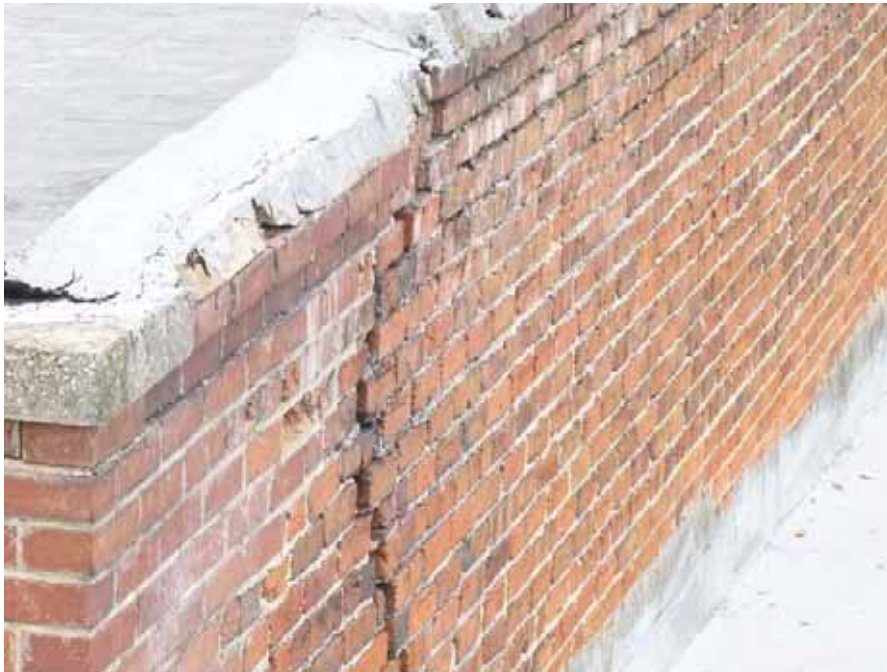
92. Building R - masonry repair is needed here; a similar condition may have existed at the opposite front corner as shown in photograph 93.

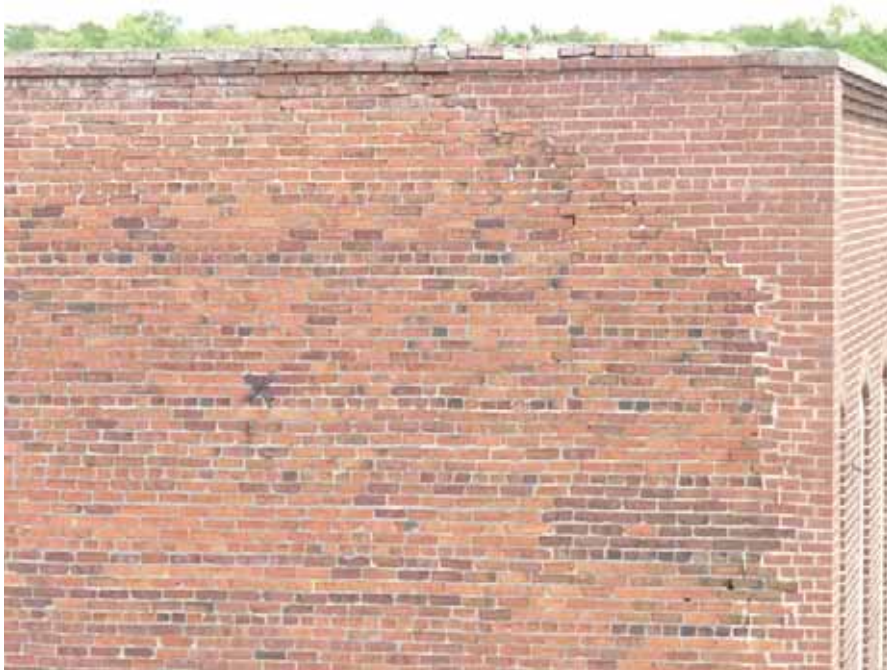
93. Building R - previous masonry repairs.

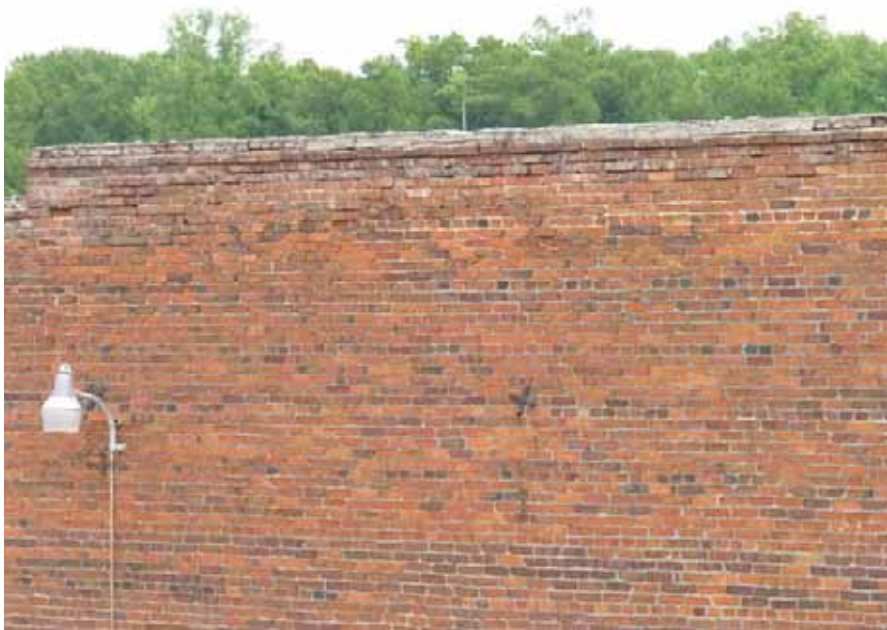
94. Building R - masonry at parapet needs repair; see closer view in photograph 95.

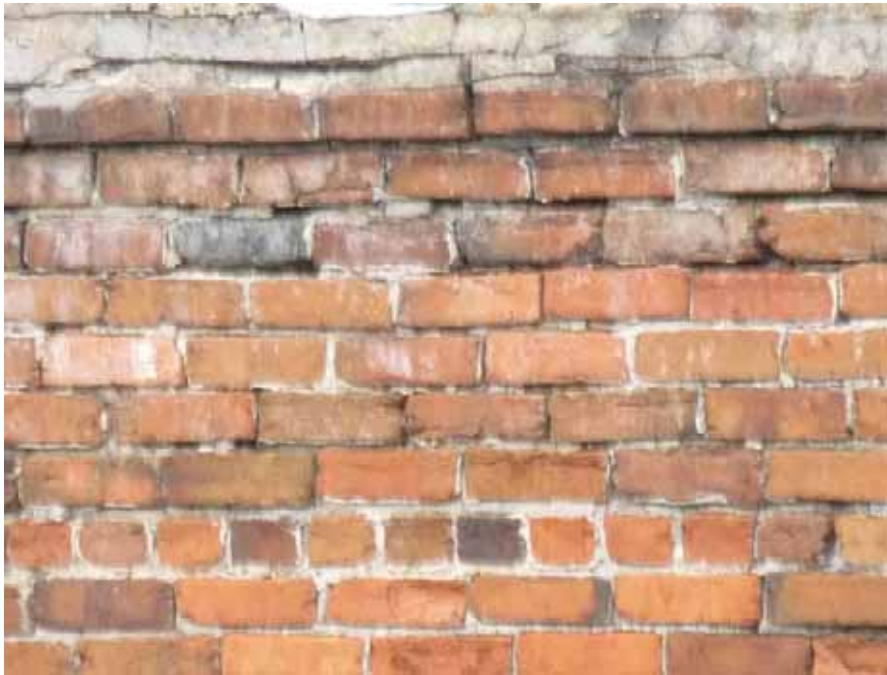
95. Building R - closer view of needed masonry repairs.

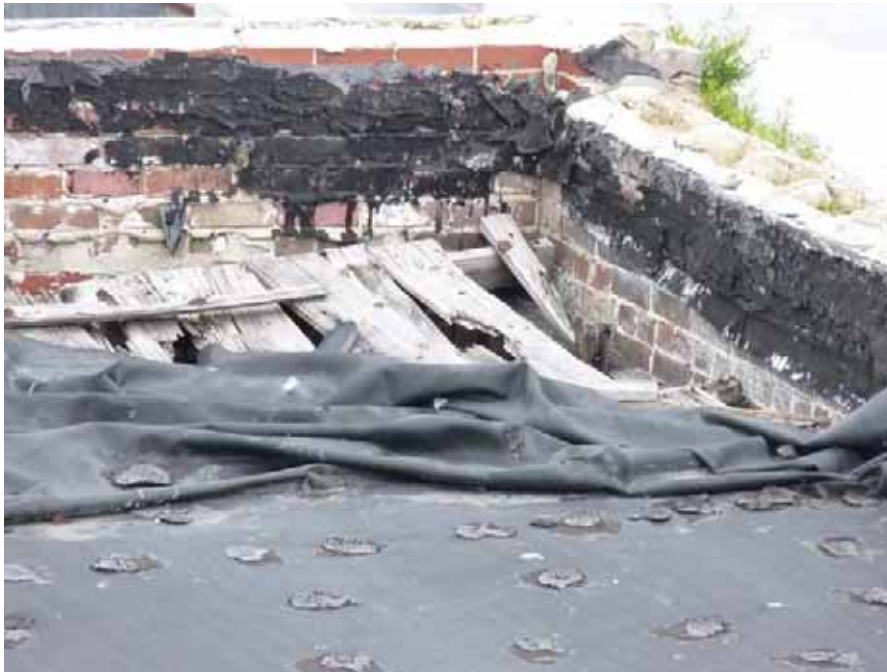
104. Building S - closer view of deteriorated wooden roof deck.

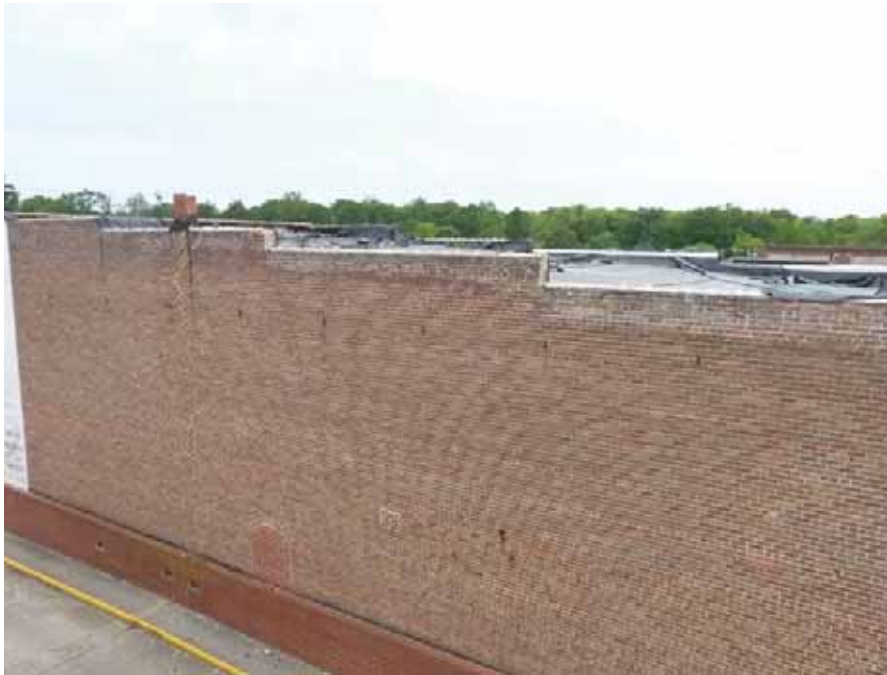
Buildings S, T &W      The parapet walls of these buildings are in need of immediate repair. A portion of the north wall of building W is specifically in need of repair as shown in the photographs.

105. Building S - parapet repair is needed; see closer view in photograph 106.

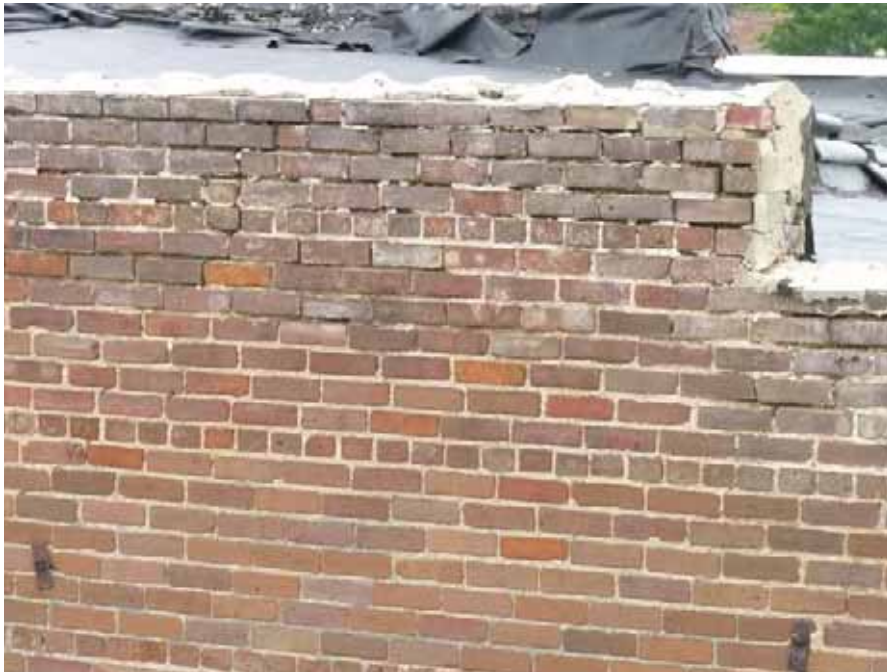
106. Building S - parapet repair is needed here.

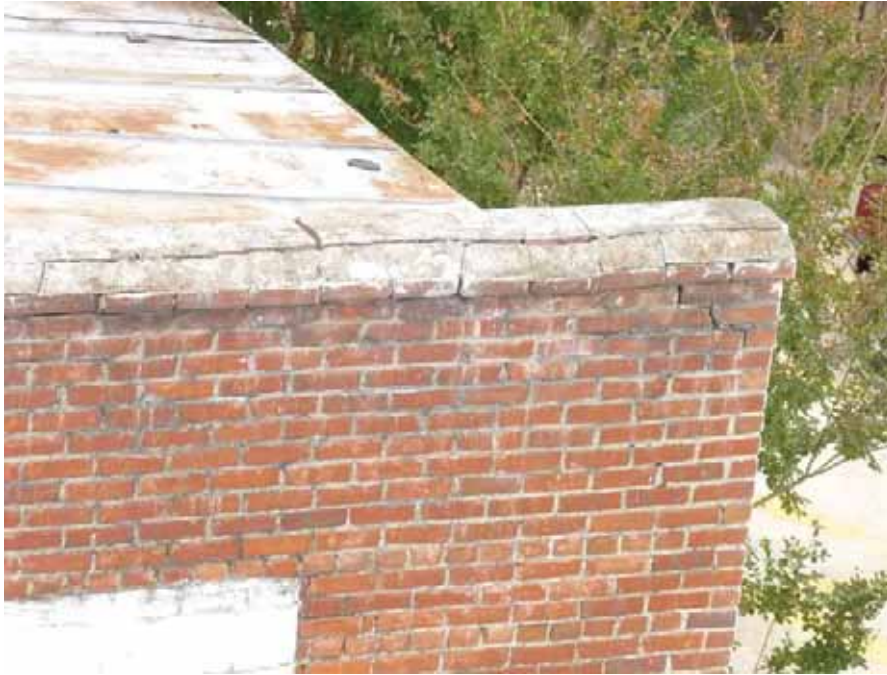
111. Building T - parapet cap is in need of repair; see closer view in photograph 112.

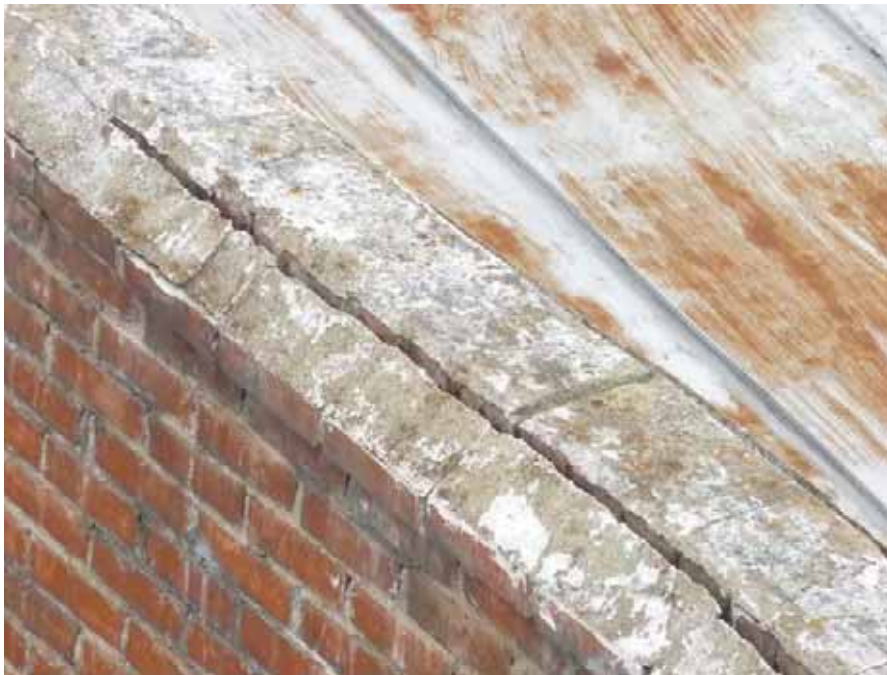
112. Building T - parapet cap is in need of repair.

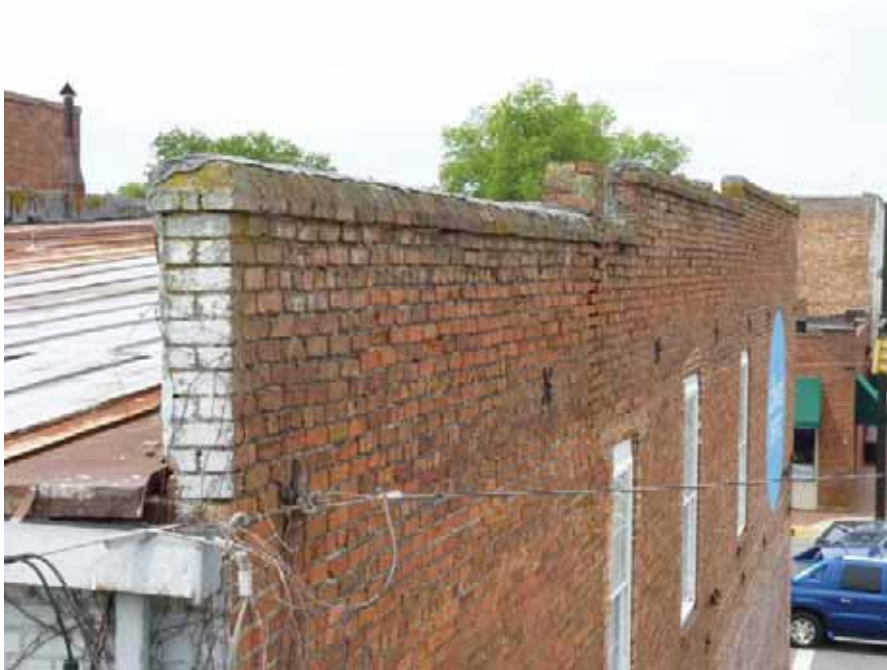
131. Building W - masonry repair needed here; see also next photograph.

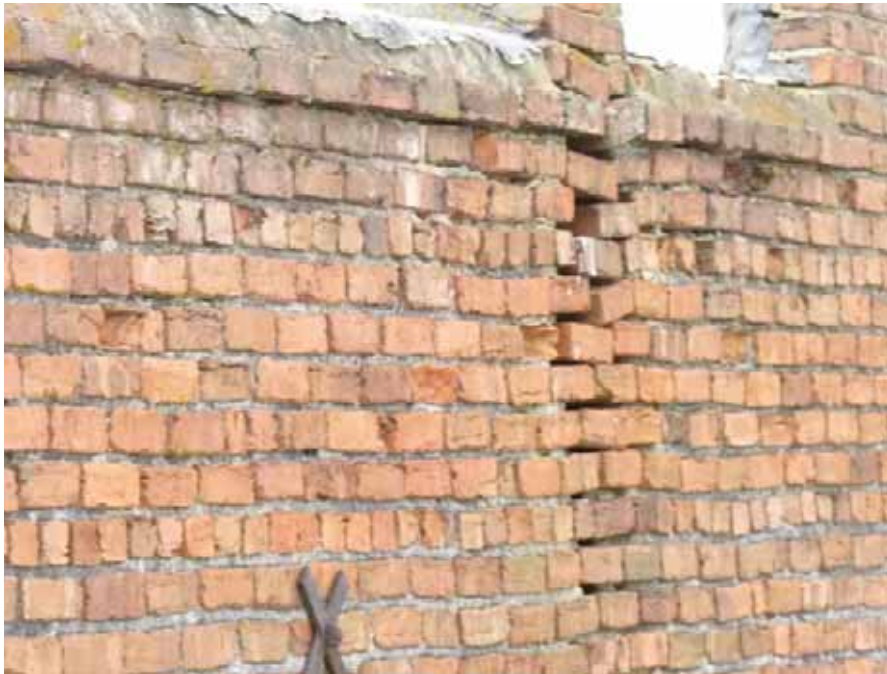
132. Building W - masonry repair needed here.

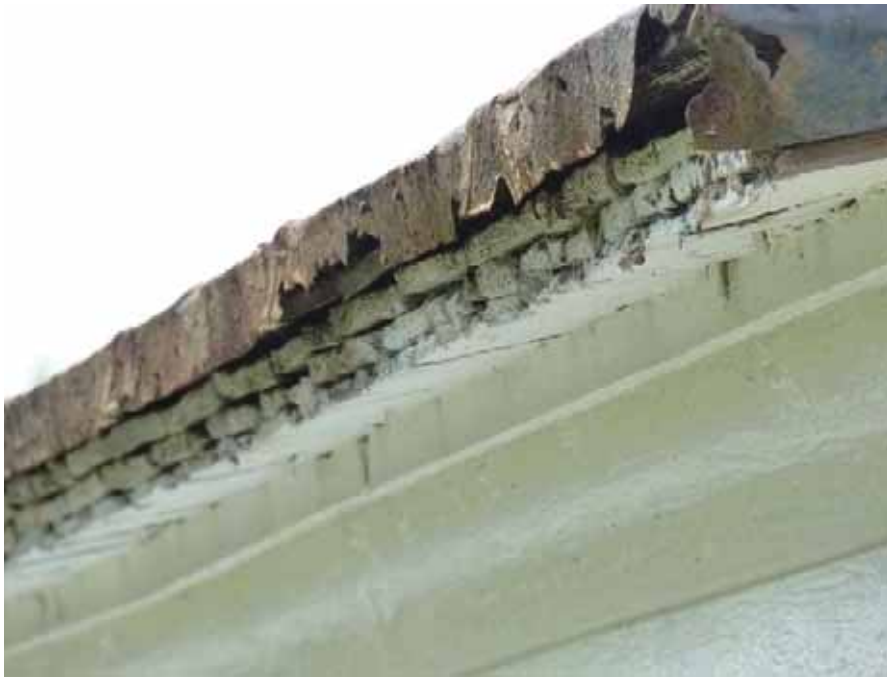
Building X      At building X, on North York Street, the sag in the east eave and east wall indicate the need for a structural review. Also, note that the metal roof has been installed over the original wooden shingles. Any future replacement of the roof system should involve removal of the wooden shingles along with the metal roof. Historical restoration may indicate that the new roof system should be of wood shingles.

144. Building X - metal panels have been installed over the original wood shingles. Metal is severely rusted at the eave.

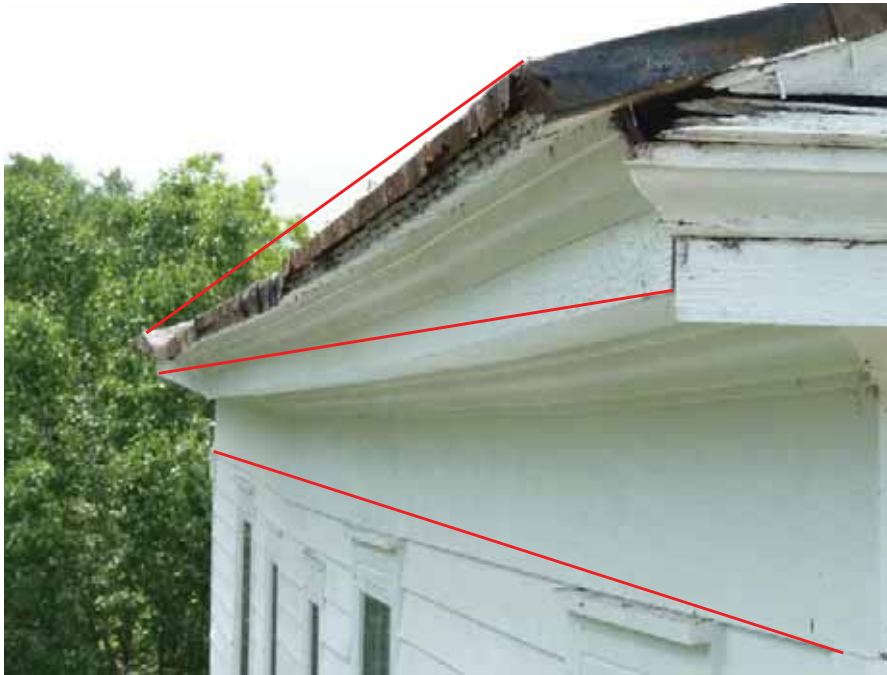
145. Building X - eave and wall sag; red lines have been added as a reference.
