# Town of Windsor, NC

## CPN Institute Re:NC Report Facilities Revitalization Overview

Site Visit: May 19-20, 2011  
Final Report: September 1, 2011

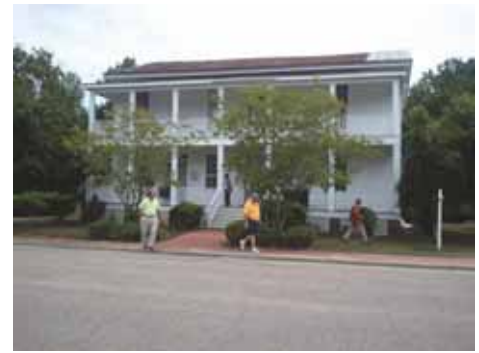
<b>Building Name</b>	Freeman Hotel Home for Chamber of Commerce	
<b>Address</b>	101 North York Street	
<b>Built</b>	1840s Historically significant for community	
<b>Building Footprint</b>	60' x 40' (Approximately) 2 floors	
<b>Type of Construction</b>	Foundation:	Brick Bearing, assumed brick intermediate piers Elevated 36"-40" above grade
	Floor 1:	Wood framed Finish wood floors were 'wavy', most likely due to swelling while wet Interior walls had sheathing removed
	Floor 2:	Wood framed
	Roof:	Wood framed, sloped Deflection noticed along ridge Metal roof panels appear extremely 'weathered'
	Walls:	Wood siding, painted No exterior sheathing nor moisture barrier observed Some wood lath inside stud faces
	Landscape:	Nice grass yard Mature trees and shrubs

<b>Recommendations</b>	<p>Raise building if kept in current location and reinforce foundation.          Raising building will pose aesthetic and accessibility issues.          Scale of foundation may not 'feel' right for this building.          Consider: Relocating closer to main Downtown District.</p>
------------------------	--

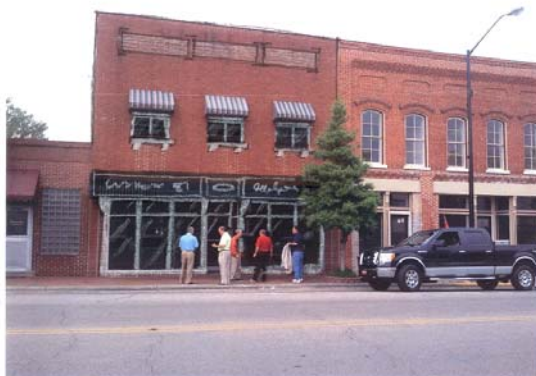
Building front facade is more contemporary than other buildings observed. The brick pattern and condition of the brick on the front appears to be constructed more recently. The storefront is aluminum framed system with no intermediate mullions and lacks historical character. This building did not receive flood damage. Upper floor requires further inspection due to neglect and evidence of roof leaks particularly at edge of roof. Rear wall has some historical character with arched upper windows. There is a 1-story 'addition' on the back composed of painted concrete block (CMU). The interior stair is wide and has the potential to 'draw' visitors inside and upstairs.

Upgrade awning over main storefront. Add character using pots with flower. Replace upper floor windows with traditional wood windows with mullion pattern. Connect upper floor windows with a single permanent awning. Replace aluminum storefront with a traditional entry using durable materials. Capture rear yard as a people-oriented space...consider converting several parking spaces to patio with landscaping.

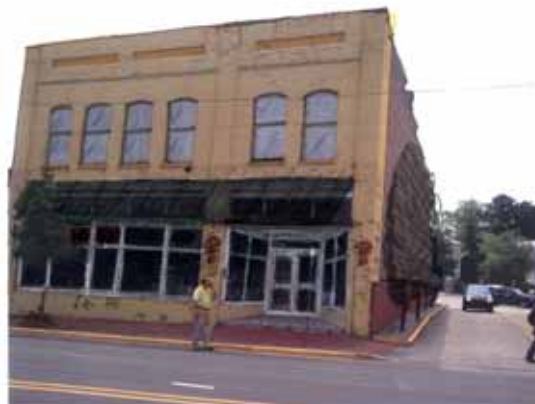
<b>Building Name</b>	<b>Miller Building</b>		
<b>Address</b>	137 East Granville Street Central Business District		
<b>Built</b>	Approximately 1840s		
<b>Building Footprint</b>	Approximately	Floor 1:	45'-0" x 82'-0" = 3,690 sf 18'-0" x 41'-0" = 738 sf
		Floor 2:	45'-0" x 82'-0" = 3,690 sf
<b>Type of Construction</b>	Foundation:	Brick Bearing, assumed brick intermediate piers Entrance located on grade	
	Floor 1:	Wood framed, no deflection noticed Finish wood floors	
	Floor 2:	Wood framed	
	Roof:	Wood framed, low slope ('flat')	
	Walls:	Load-bearing masonry, appear solid	
	Landscape:	Rear faces immediate parking lot

Upper floor requires further inspection due to neglect and evidence of roof leaks particularly at edge of roof.

This building appears to be one of the most expensive to repair.

Even though the building has been considered for demolition, it remains a significant component to the Downtown fabric and should remain. Inspect floor and roof framing for damage and replace structural components as needed.

Replace retractable awnings.

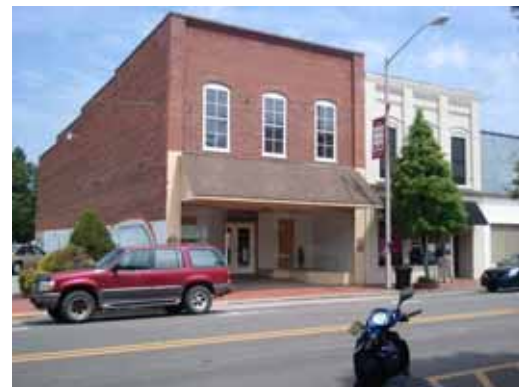
<b>Building Name</b>	<b>NCDMV Building</b>	
<b>Address</b>	122 East Granville Street Central Business District Owned by Town	
<b>Built</b>	Unknown	
<b>Building Footprint</b>	Approximately	Floor 1: 25'-0" x 100'-0" = 2,500 sf Floor 2: 25'-0" x 100'-0" = 2,500 sf
<b>Type of Construction</b>	Foundation:	Brick Bearing, assumed brick intermediate piers Entrance located on grade
	Floor 1:	Slab on grade with vinyl floor coverings
	Floor 2:	Wood framed (assumed)
	Roof:	Wood framed, low slope ('flat')
	Walls:	Load-bearing masonry, appear solid
	Landscape:	Rear and left side face immediate parking lot

Permanent awning is out of scale with front façade and could be replaced with a more traditional approach using lighter, more colorful materials.  
 Add a traditional cornice across top of front façade.  
 Introduce signage.  
 Consider introducing streetscape scene along wall facing parking lot.  
 Add awning over rear entrance with patio-like seating areas. Landscape a small area in the rear.  
 Open up blocked up windows in rear wall.

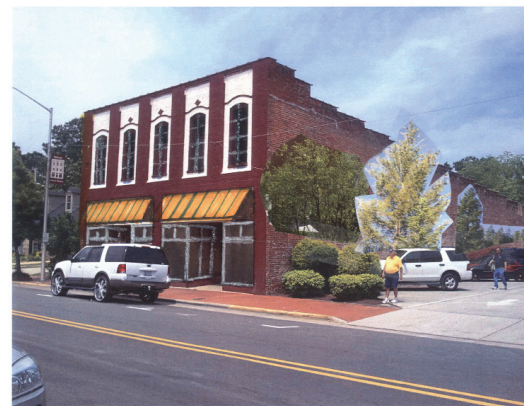
**Building Name** Old Western Auto / NY Lane

This building (of those observed) is the largest distance from the River. Traditional storefront with good brick detailing. The brick pattern includes arched windows on second floor with accents. The storefront is missing and is currently 'boarded up.' The rear half of the building has been burned away. The rear wall is 1-story in height and remains standing. The wall has 4 arched windows and an arched entry, and a chimney (flue). There is a lot of potential for this building. The large parking area around the building (combined with 122 East Granville) could become a very special area in the Downtown if a portion of the parking were devoted to people/green space.

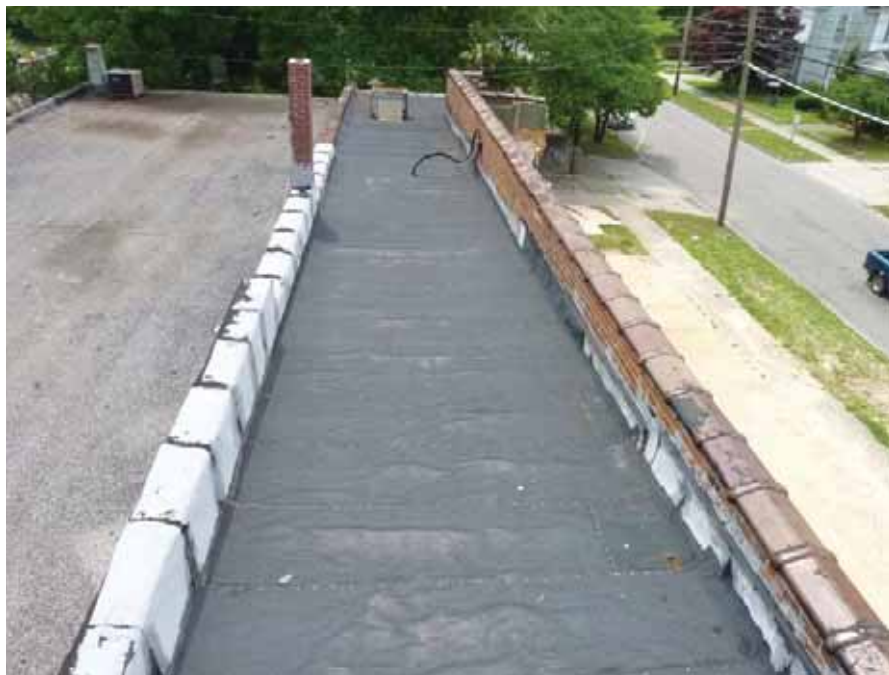
4. Building A roof.

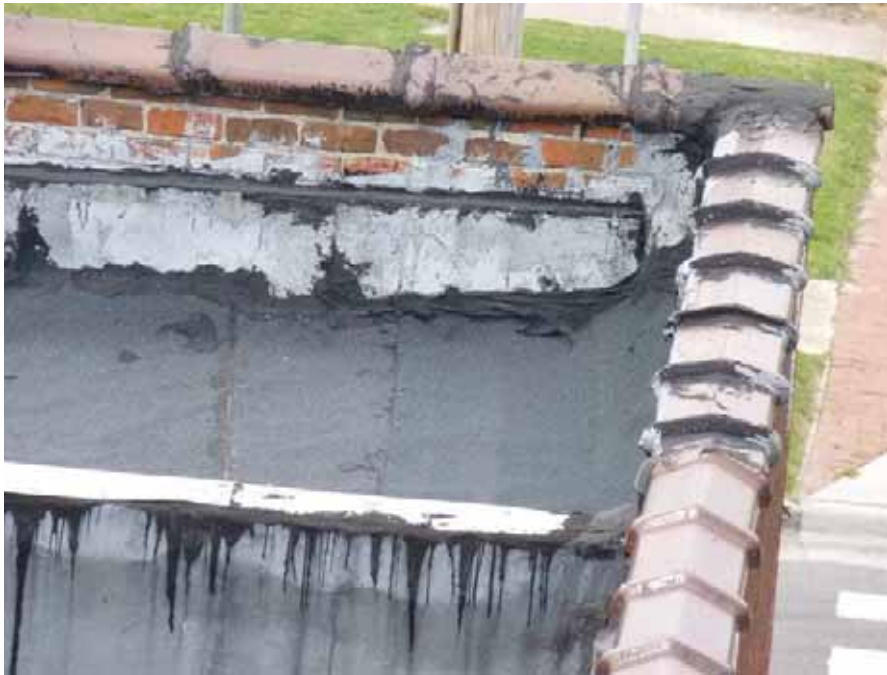
5. Building A - parapet.

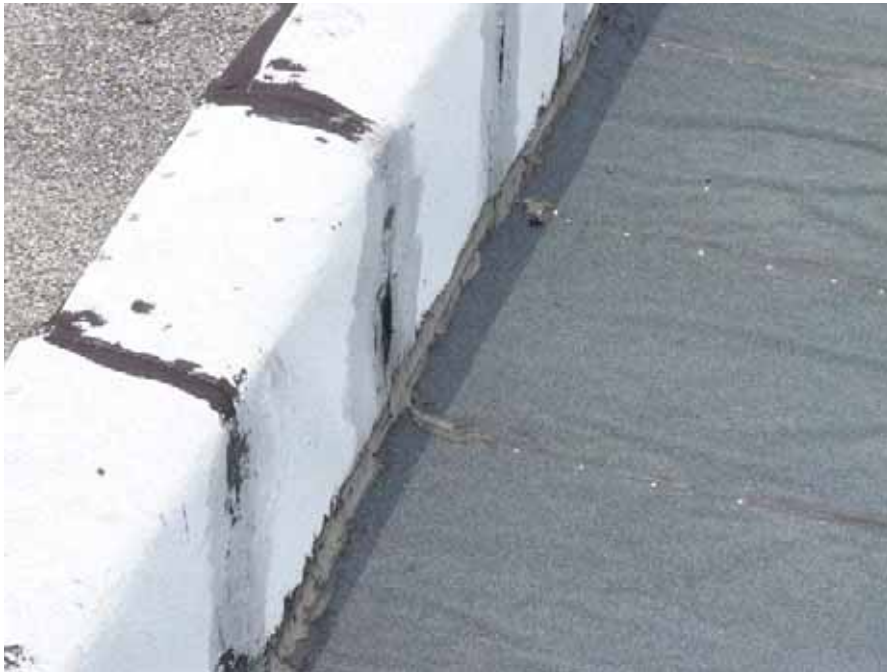
6. Building A - parapet between A and B.

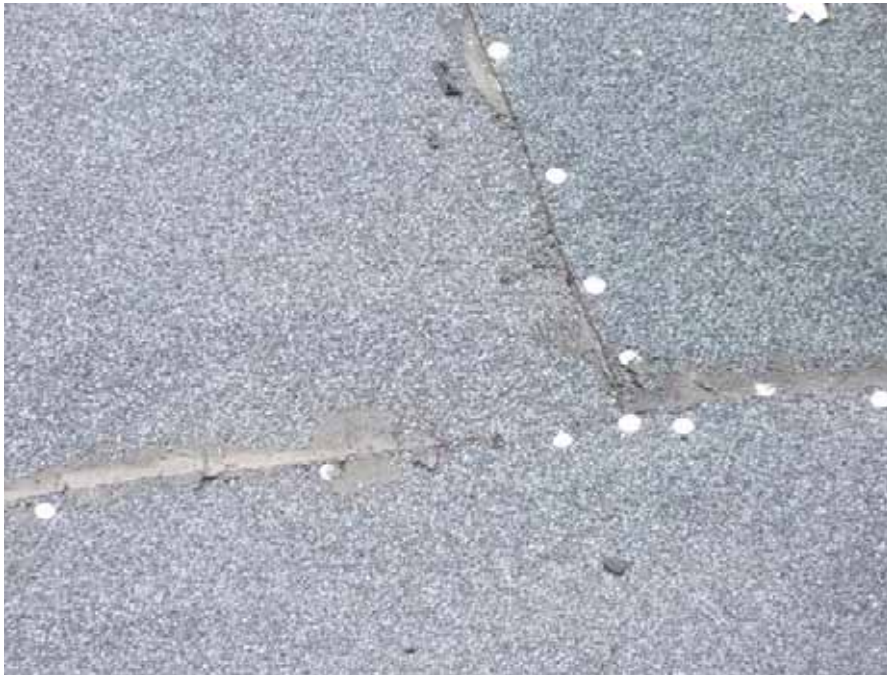
Bldg	Address/Name	Roof							
		Area (s.f.)	Type	Condition	Cost				
					Emergency Repair	Repair	Reroof	Parapet repair Length (l.f.)	Cost
A	103-129 E. Granville St.	1,396	Granule surfaced cap sheet	Exposed nails		\$750	\$4,188 Coating	75	\$3,000
B	105 E. Granville St.	2,400	Gravel surfaced built-up membrane			\$3,000			
C	107 E. Granville St.	221	Asphalt shingles			\$300			
D	107 E Granville St.	1,617	Smooth surfaced built up membrane			\$3,000			
E	113 E Granville St.	1,470	White coating over EPDM			\$1,500			
F	113 E. Granville St.	290	White coating over EPDM			\$300			
G	113 E. Granville St.	630	EPDM			\$500			
H	103-129 E. Granville St.	200	EPDM			\$300			
I	103-129 E. Granville St.	1,800	EPDM			\$1,500			
J	103-129 E. Granville St.	280	EPDM			\$300			
K	103-129 E. Granville St.	296	Not visible - assume EPDM			\$300			
L	103-129 E. Granville St.	3,168	EPDM			\$1,500		144	\$4,500
M	103-129 E. Granville St.	2,516	Architectural metal panels	coated with asphalt		\$1,500

7. Building A - exposed nails.

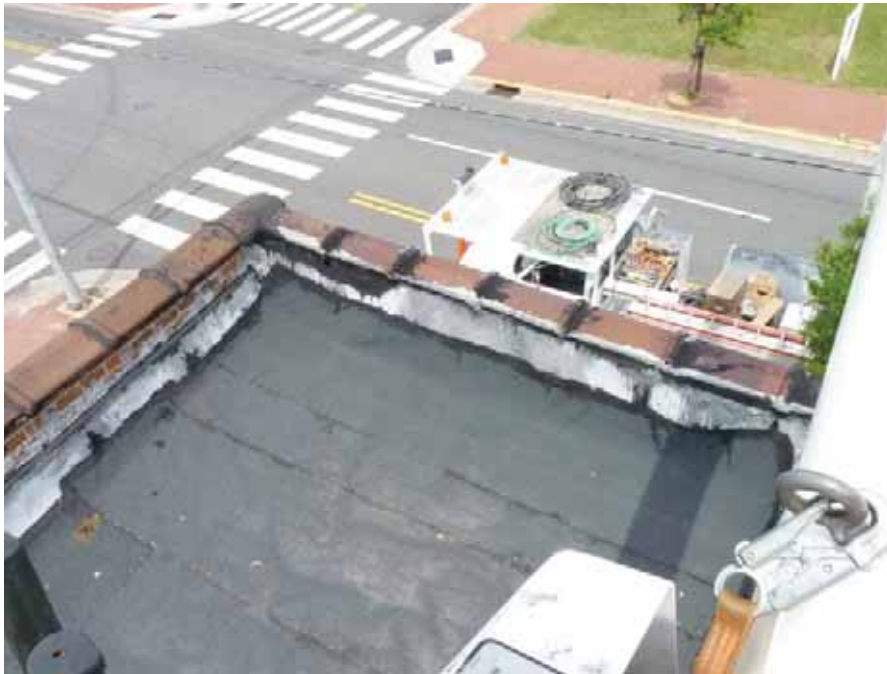
8. Building A - shows north parapet and part of west parapet.

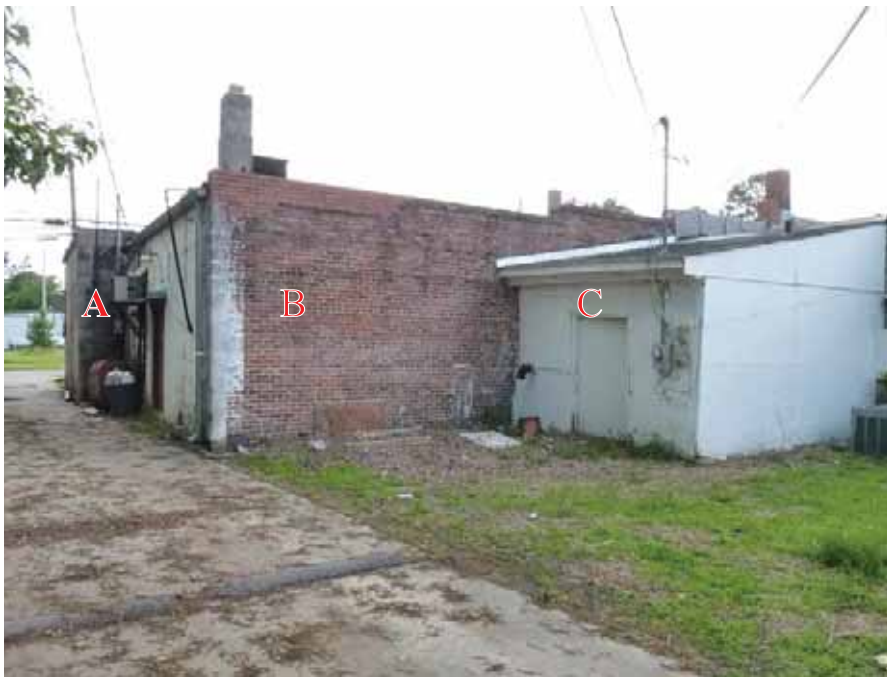
10. Rear of Buildings A, B and C.

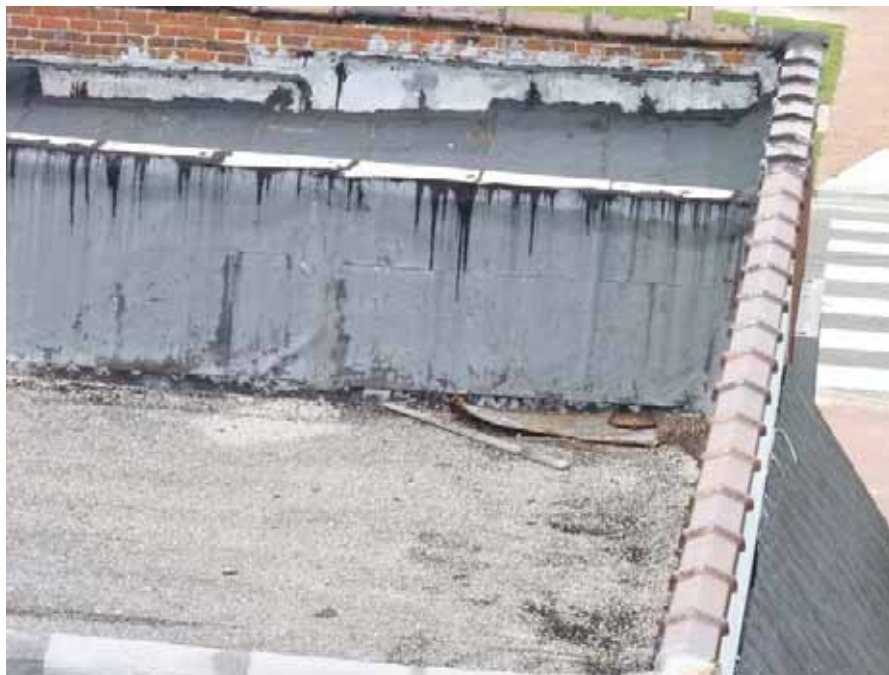
12. Building B - parapet between A and B.

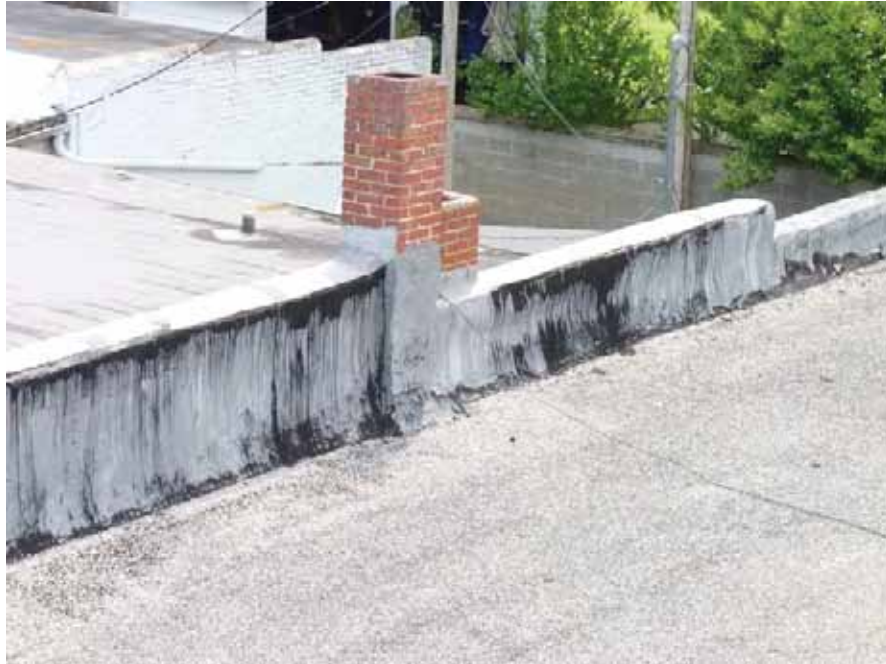
13. Building B - parapet between B and D.

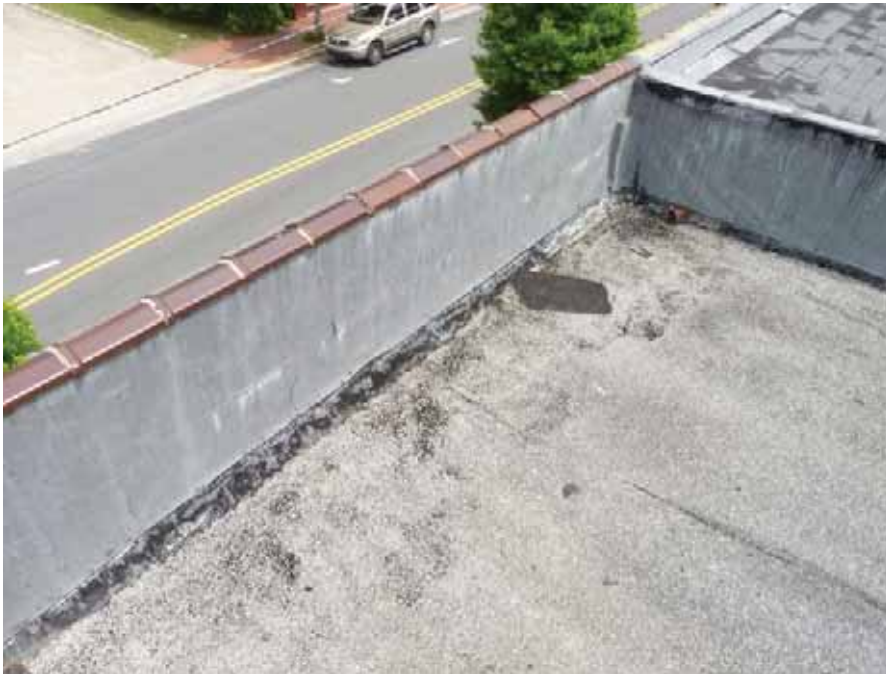
14. Building B - back of front parapet.

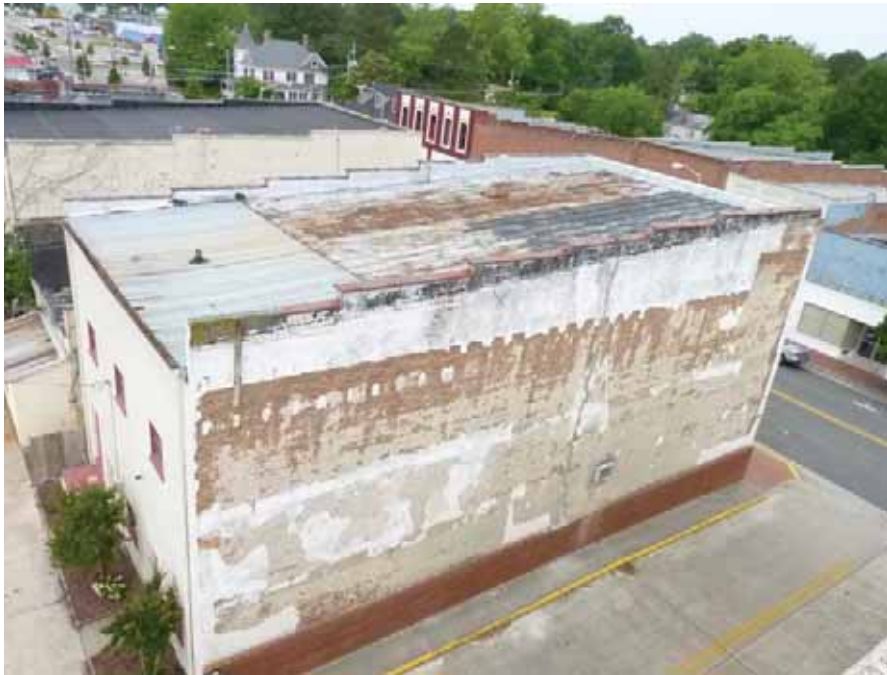
69. Building P - building to the east has been demolished.

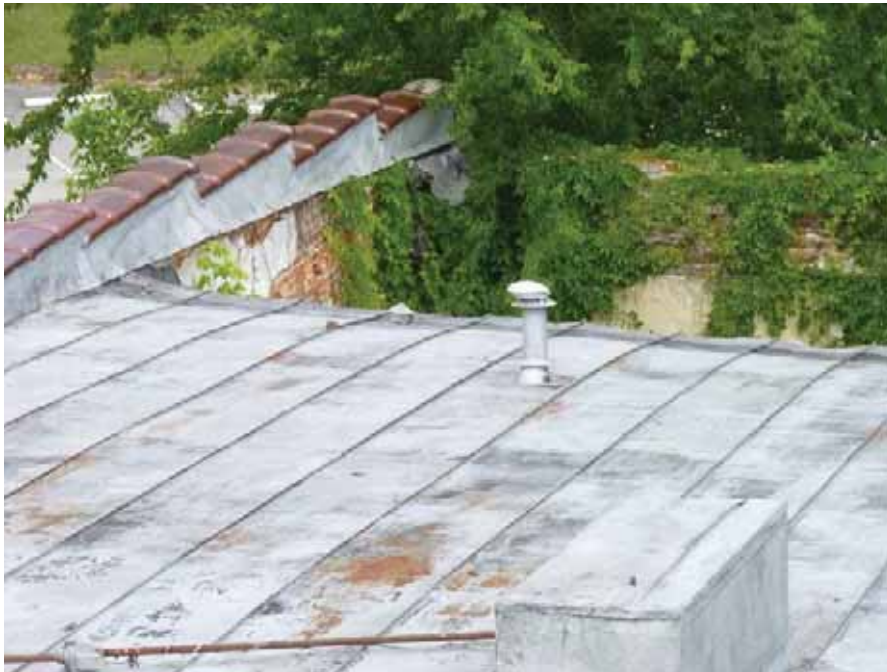
114 E. Granville Street      This roof appears to be keeping the interior of the building dry, however, the northerly 20' of the roof and roof structure has collapsed. The charred roof truss members are evidence of fire damage. The extent of the fire damage within the remaining roof structure should be determined.

80. Building Q - rear 20' of the roof structure has collapsed.

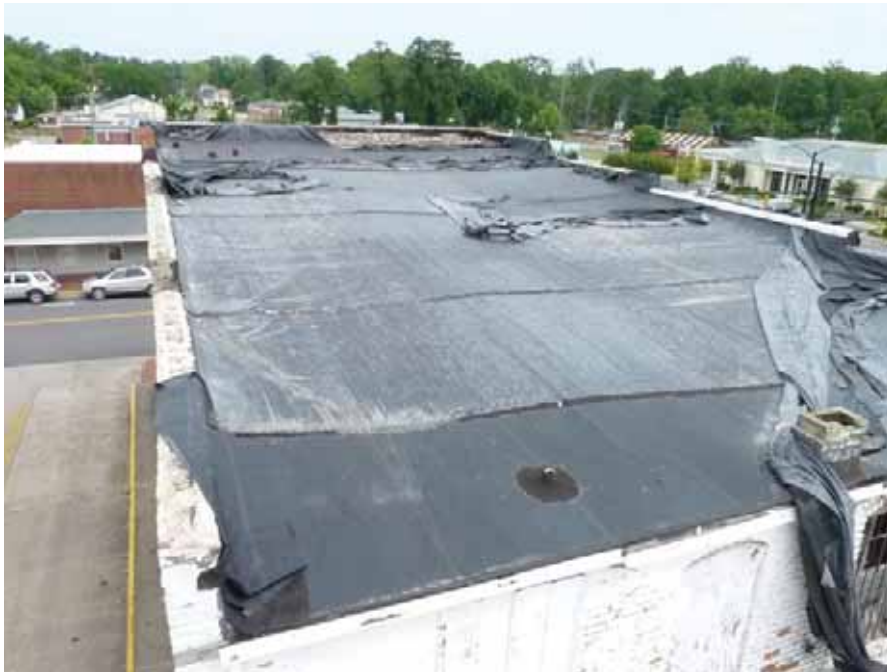
100. Building S -rubber sheets have been applied in an attempt to protect the building, however, many sheets have been displaced by wind forces.

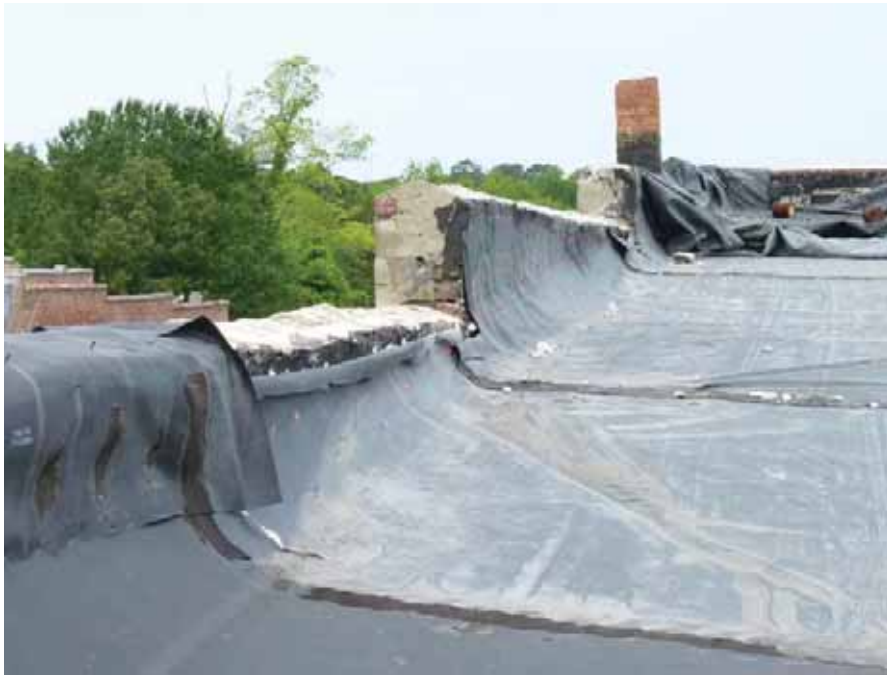
101. Building S - water may enter at the parapet flashings.

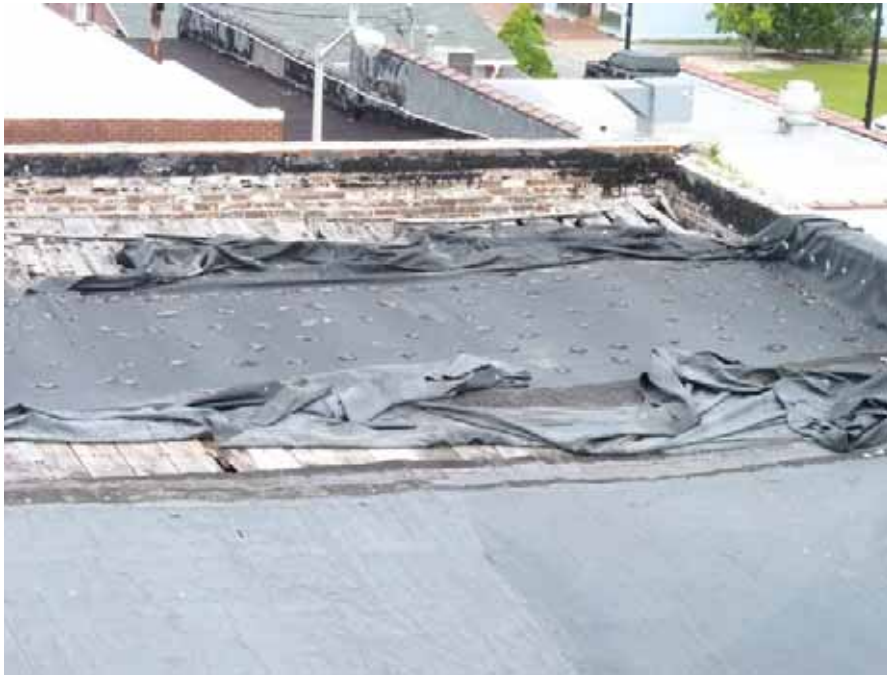
103. Building S - wooden roof deck is exposed to the weather at many locations.

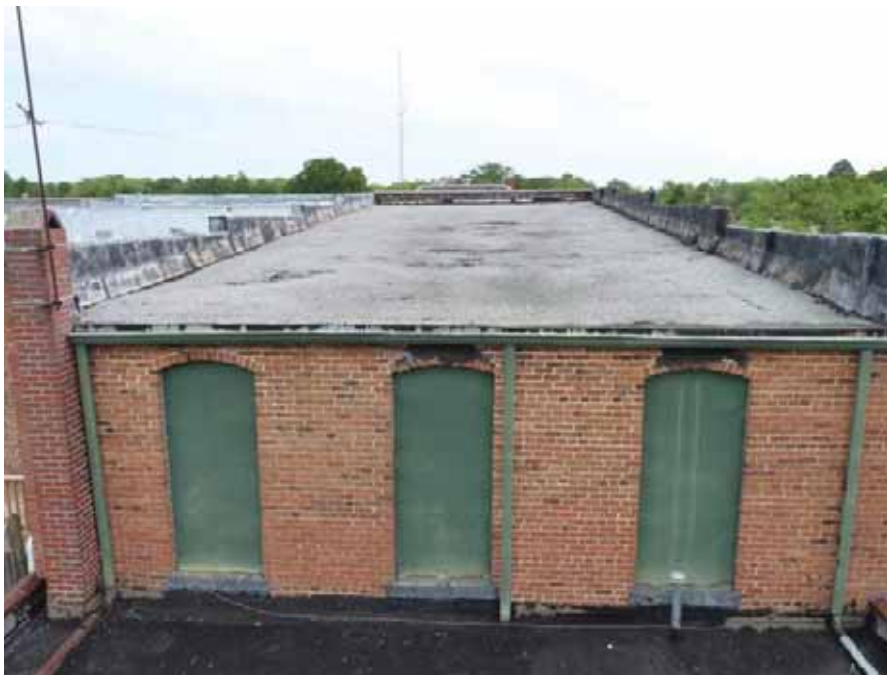
116. Building U - roof structure sags at the rear of this roof.

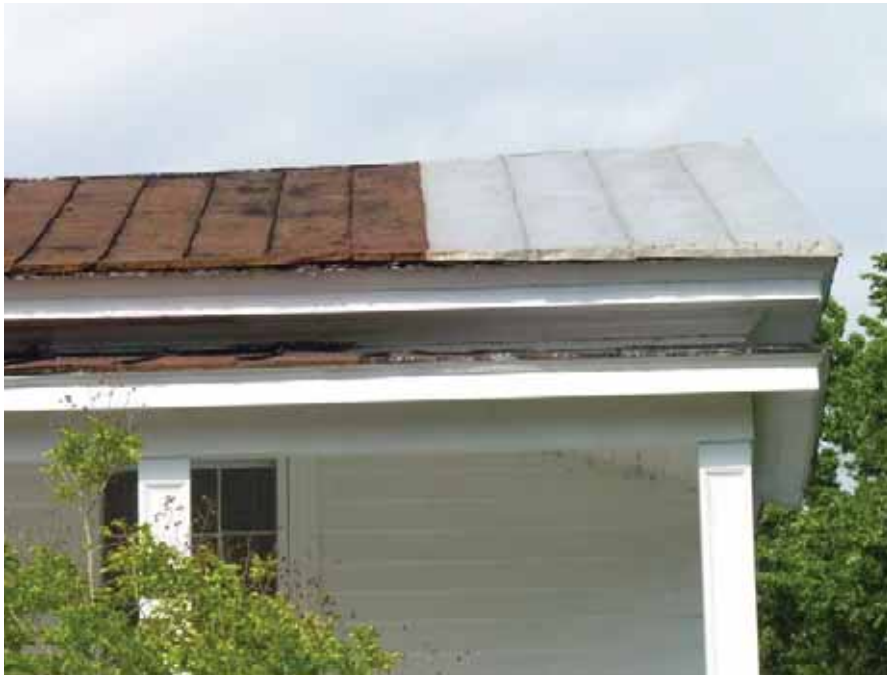
137. Building X - some metal panels have been coated.

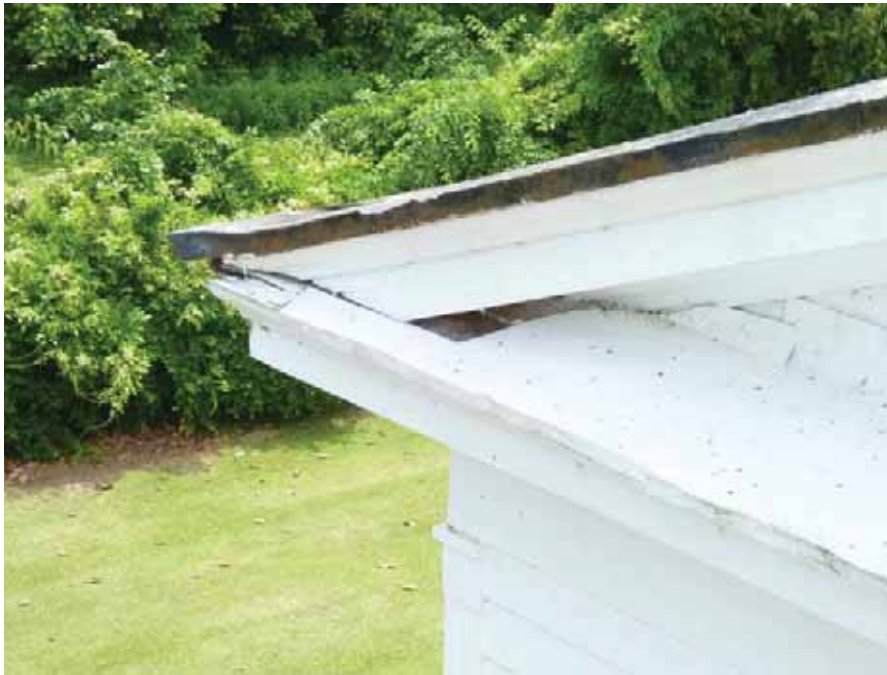
139. Building X - water table flashing does not extend fully across the top of the water table; water may enter here.

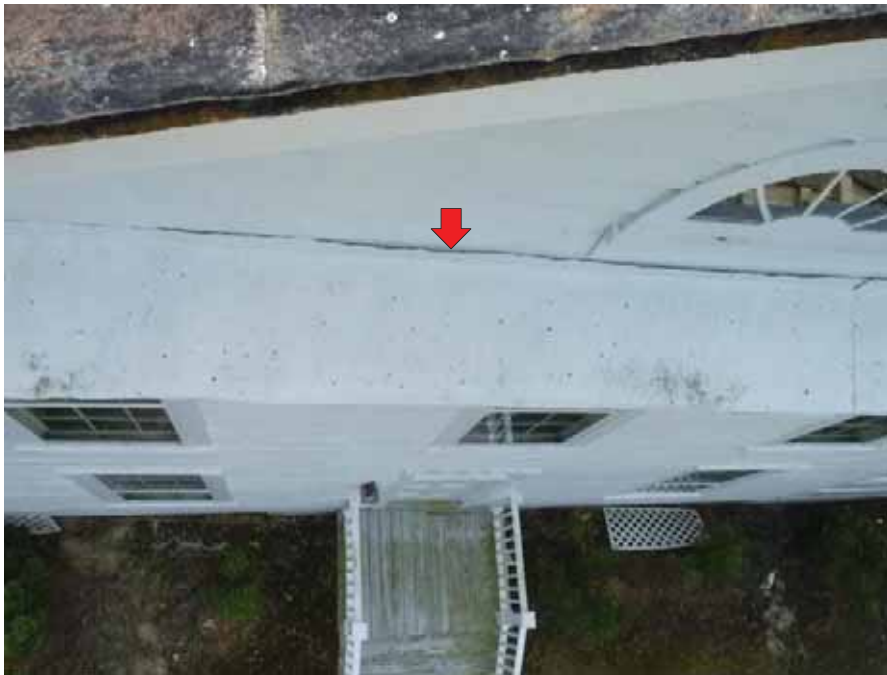
140. Building X - looking down on water table; sheet metal flashing is open at the top and water may enter here.

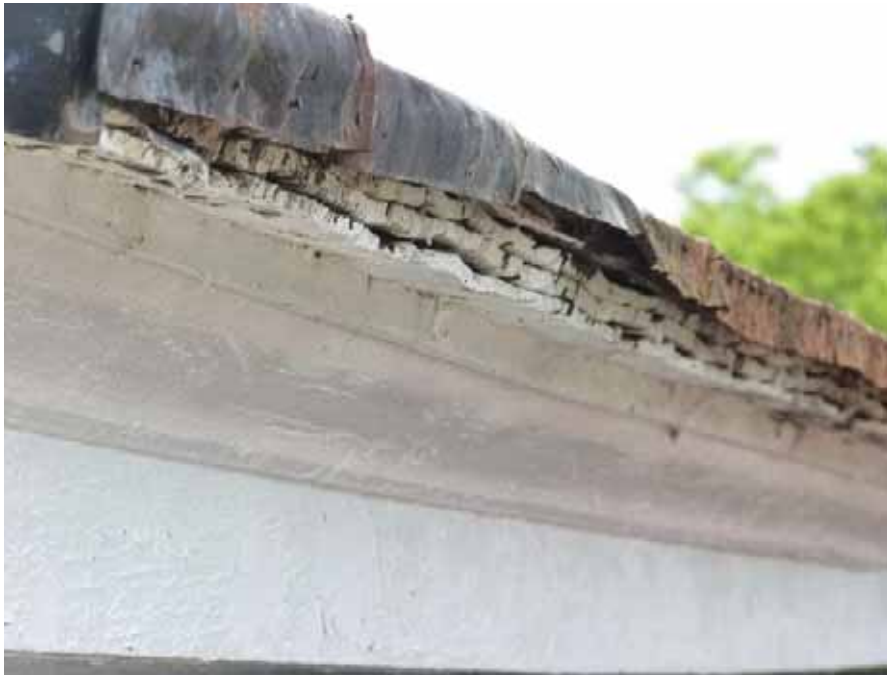
147. Building X - metal panels have been installed over the original wood shingles. There may be two applications of wood shingles.
